Rehabilitation of R14 Balti-Sarateni Road

**Lot 2: km 43+000 to km 61+000 and
km 64+370-km 66+657**

Road Safety Audit Findings

Tendering No. RSP/2013/OT/W6

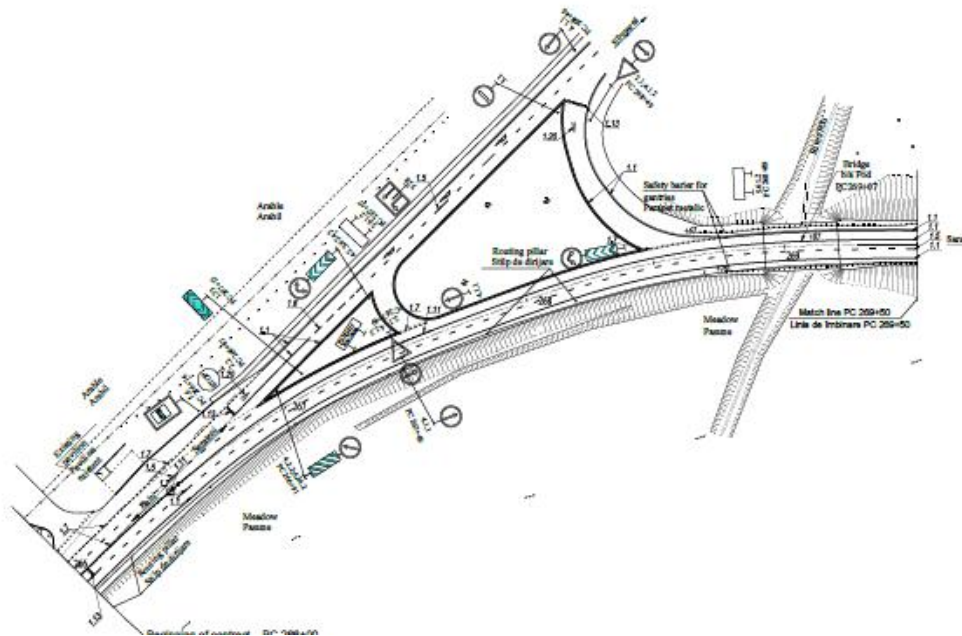
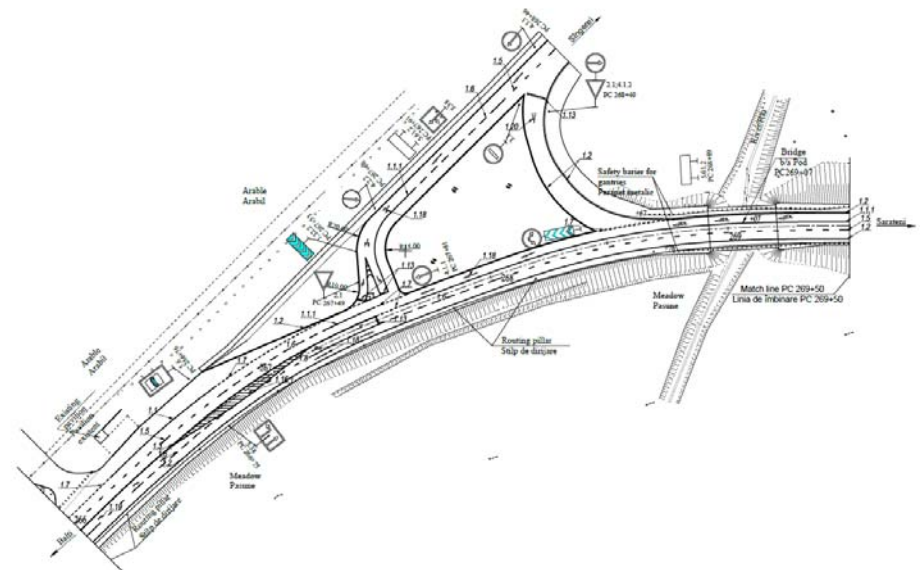
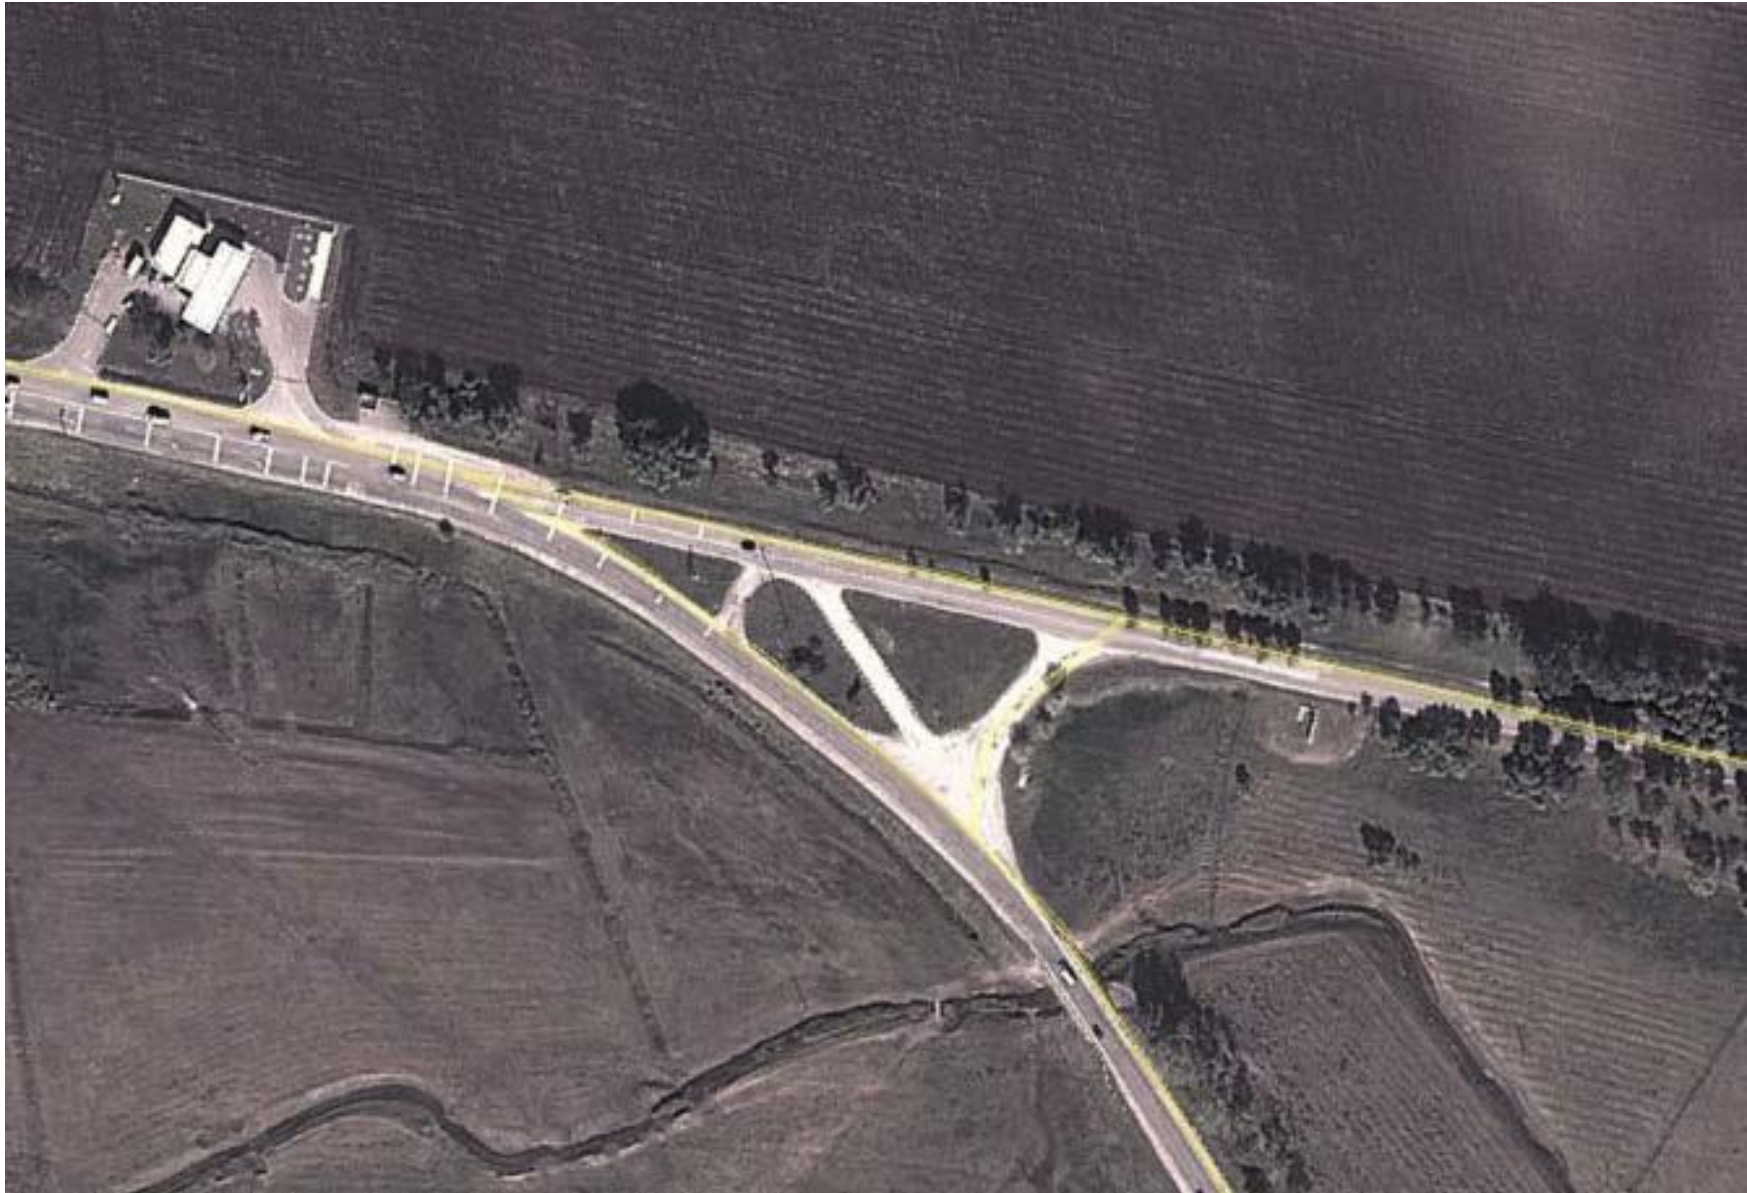
8A: Road R14 – Sheet 1 – km 26+600

From this drawing, it appears that vehicles travelling from the direction of Balti are not able to make a legal left turn towards Singerei. This may cause confusion and possibly conflicts, as drivers attempt to turn left illegally at one of the three gaps with opportunities to do so.

The layout of this intersection requires redesigning, with consideration given to the safe movement of all vehicles and pedestrians where appropriate. Safe design means that each manoeuvre from each direction must be possible with the absolute minimum number of possible conflict points. A suggestion for this location may be the construction of a roundabout intersection, giving equal and predictable priority to vehicles approaching from all directions. This type of intersection should be familiar to drivers as unusual layouts create confusion, and confusion often leads to collisions.

The junction will be rearranged during the preparation of the Construction Drawings as per the drawing on the right.

This is an improvement as it allows for all turning manoeuvres but it could be simplified by utilising the right turn filter road as the T-Junction. The exact layout should be designed after determining which the major and minor roads are. Another advantage is that it moves the junction away from the garage entrance.

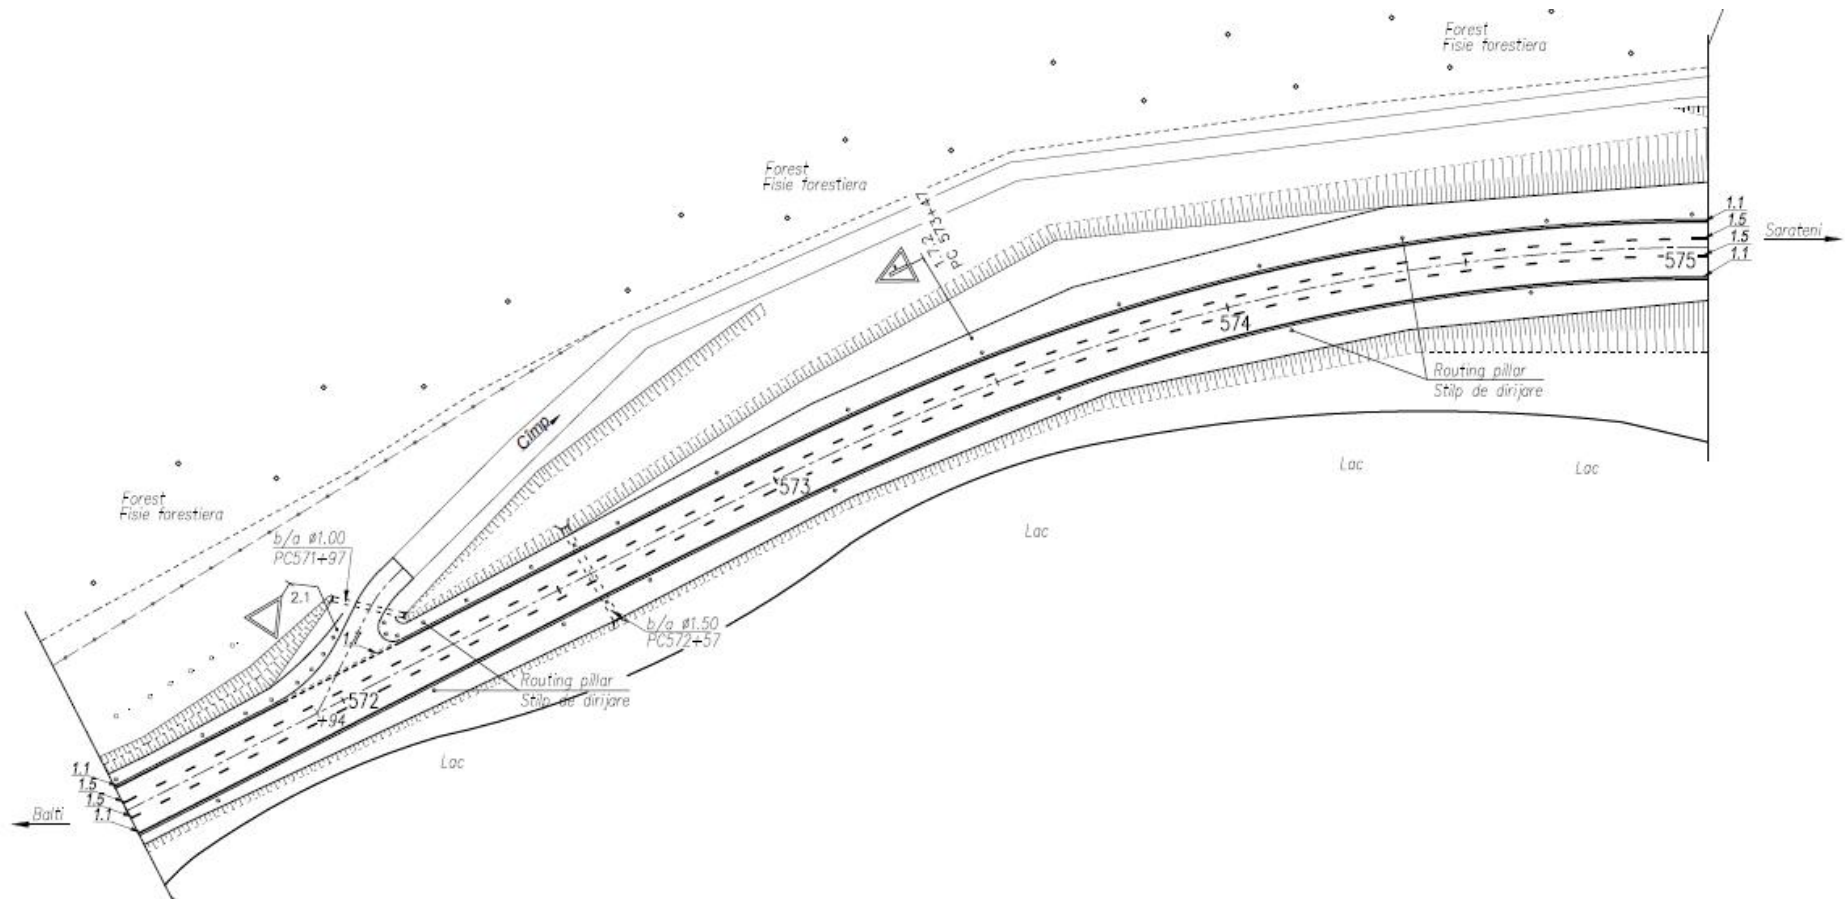
8CC: Road R14, Sheet 17 km 57+200

The entry angle of this intersection is acute. This may lead to vehicles not slowing down completely before entering the main road, possibly causing problems for pedestrians crossing the intersection.

Build out the side of the intersection so that it is perpendicular to the main road, ensuring that all vehicles slow down to make their turns.

This is an entrance to a field and shall be closed off. **ACCEPTED**

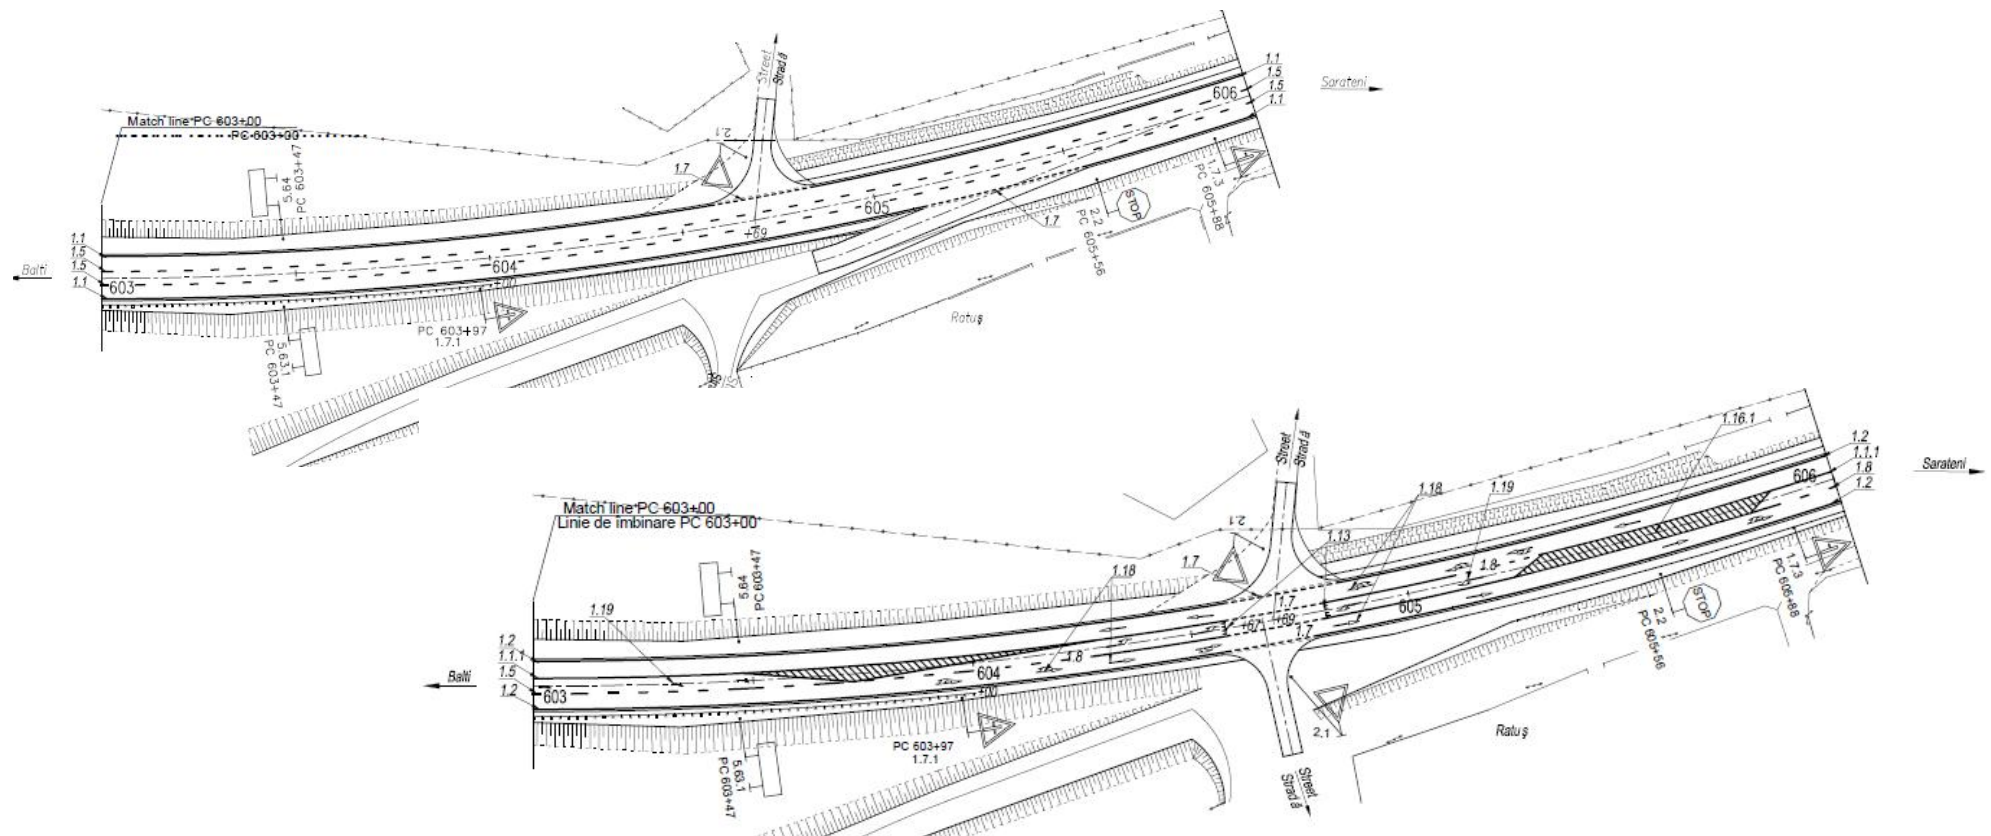
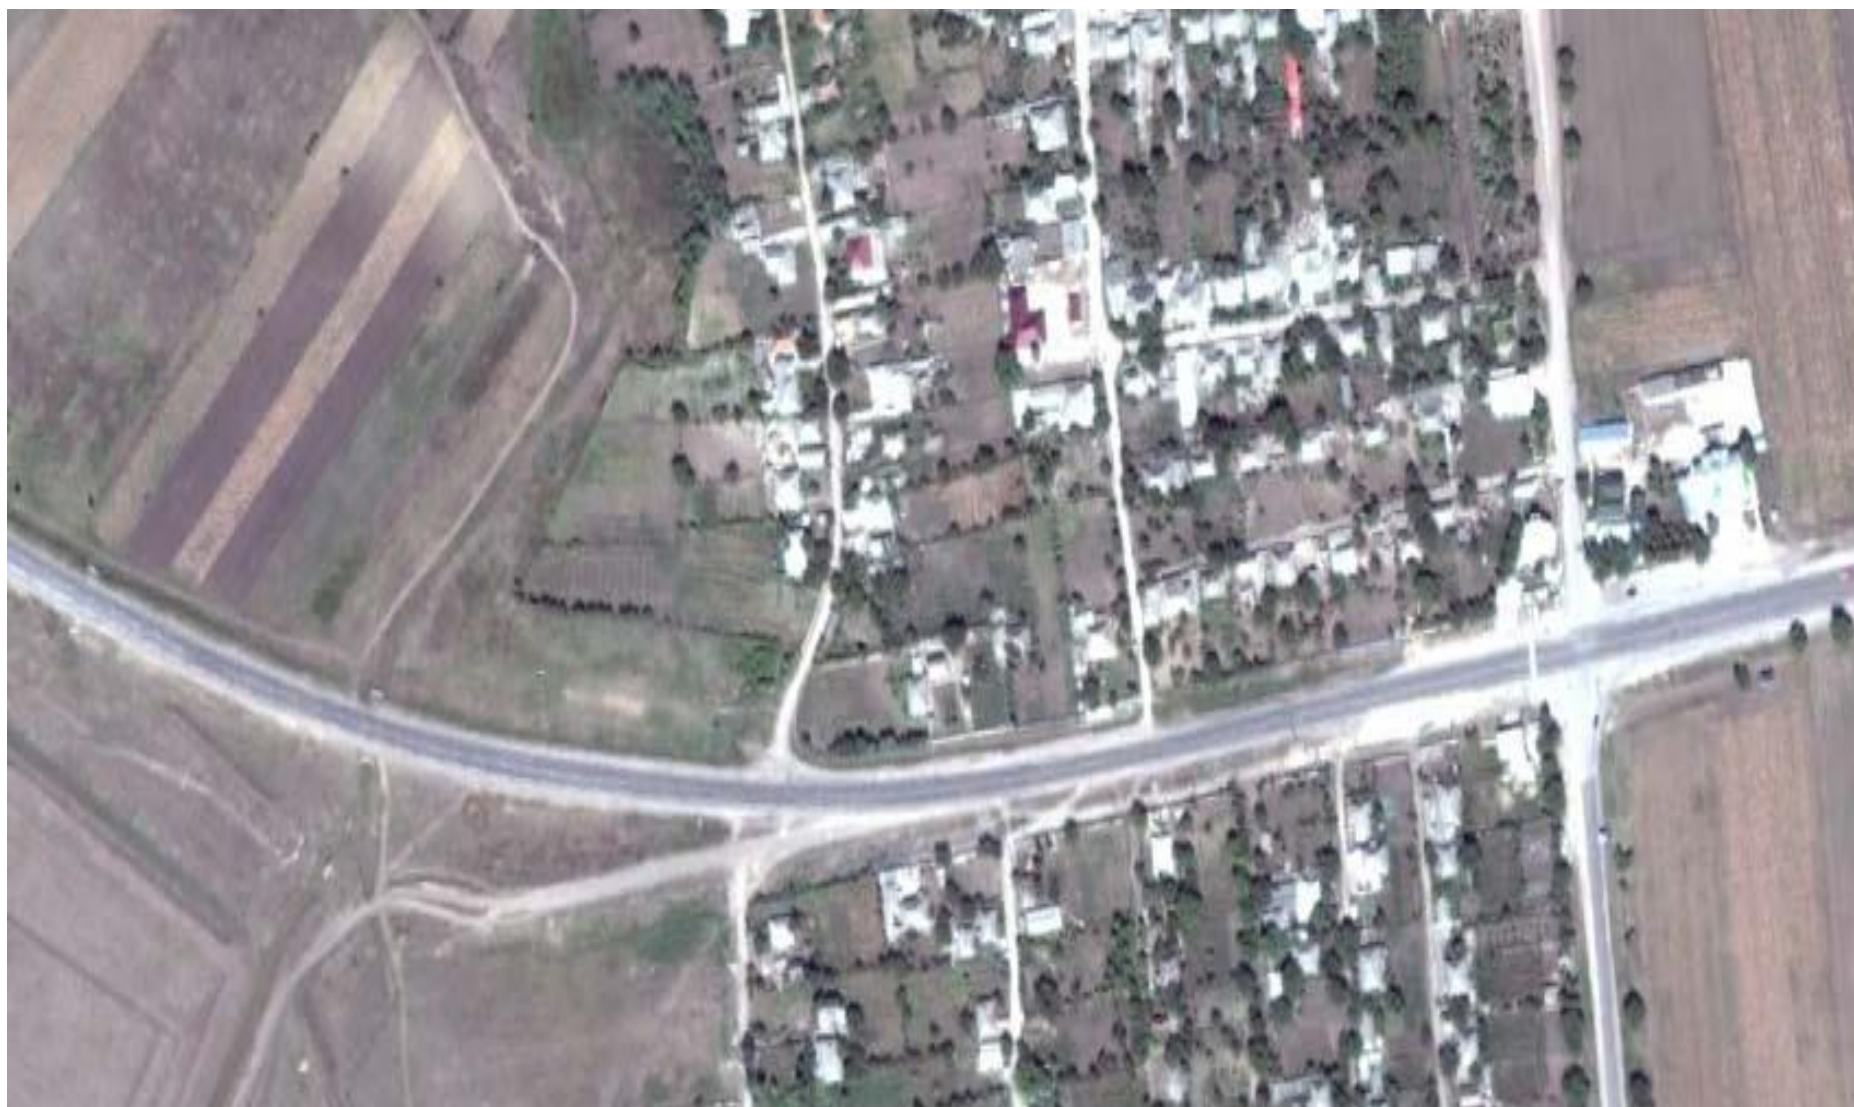
8EE: Road R14 21 km 60+500 PROBLEM

The entry angle of this intersection is acute. This may lead to vehicles not slowing down completely before entering the main road, possibly causing problems for pedestrians crossing the intersection.

Build out the side of the intersection so that it is perpendicular to the main road, ensuring that all vehicles slow down to make their turns.

The junction will be rearranged during the preparation of the Construction Drawings so that the entry/exit from the secondary road is more perpendicular to the main road. See the drawing on the bottom of this page. **ACCEPTED. If traffic movements are significant consider staggering the junction**
